AS-390/SRC, AT-150/SRC REPAIR METHODS FOR MATCHING SECTION

COMMUNICATIONS

NAVSEA 0967-LP-000-0010

SERVICE NOTES

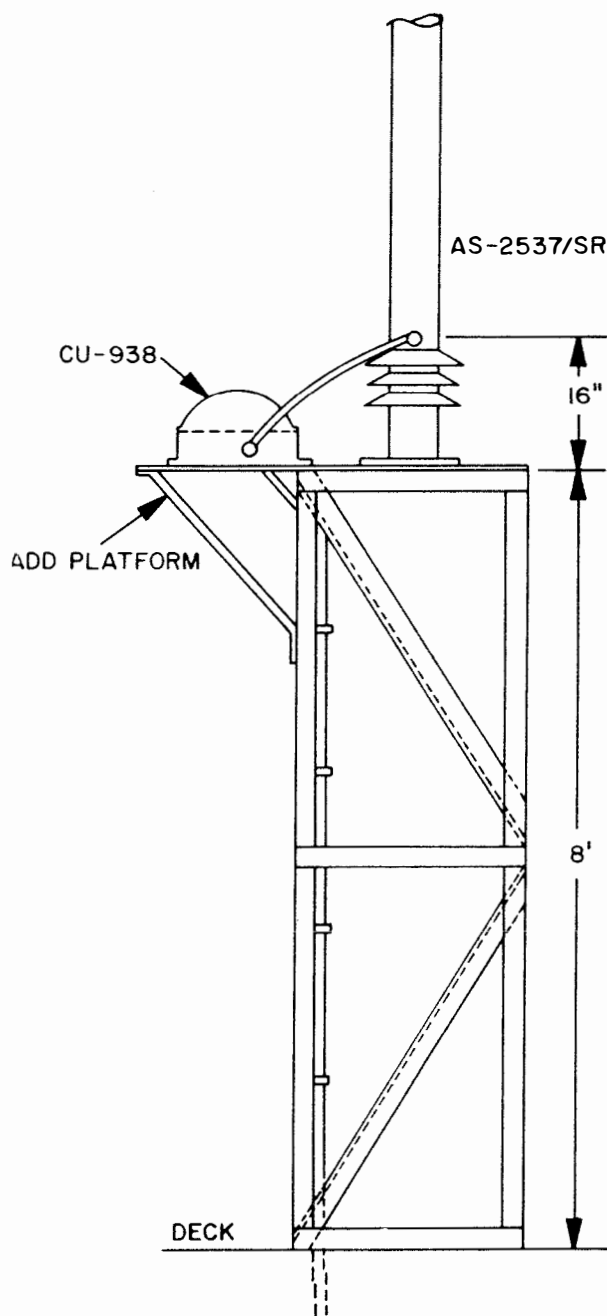
Figure 1. Whip Antenna Platform Modification
(EIB 938)

Many ships have substituted 35' fiberglass whip antennas (AS-2537/2537A) for 28 and 35' aluminum whips (NT-66046/66047) without relocating the CU-938() /URA-38 antenna coupler. Many installations have not only exceeded the allowable length of the interconnection between tuner output and antenna, but have run the interconnection through a stuffing tube penetrating the top of the antenna mounting platform. This practice decreases antenna efficiency by capacitively coupling energy into the mounting platform, and has caused arc-over between the interconnecting conductor and the stuffing tube with consequent damage to the coupler.

Some installations have been noted where the antenna coupler was properly installed for a fiberglass whip but was feeding an aluminum whip, with the interconnecting cable going down through a stuffing tube to connect to the feed point. In this situation, it is recommended that the antenna be fed at one of the mounting bolts which connects the antenna adapter base to the base insulator.

Installation instructions require the interconnection to be not more than 36" (preferred length is 12" or less) with a clearance of 6" in any direction. NAVSHIPS 0967-177-3020, SHIPBOARD ANTENNA SYSTEMS, VOLUME 2, INSTALLATION DETAILS, paragraph 3.2.2 requires that the antenna coupler be located above the antenna mounting platform. A recommended modification to existing mounting platforms is shown in Figure 1. To preclude the expense of running new cables, and to eliminate unnecessary adapters, the existing coaxial cable (RG-218/U or RG-219/U) may be extended by a short length of RG-214/U fitted at one end with a UG-21F/U plug and at the other end with a UG-23F/U jack. The control cable may be extended by use of a short length of MSCU-37 fitted at one end with an MS3101R28-21P receptacle and at the other end with an MS3106R28-21S plug.

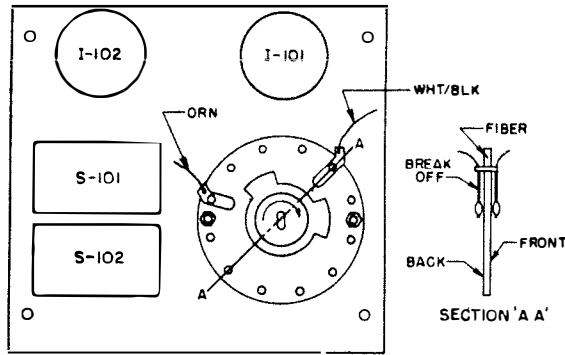
Figure 1

REAR VIEW OF C-1004A/SG SHOWING LOCATION OF CONTACTS TO BE BROKEN OFF

To increase the possible combinations of patching teletypewriters and terminal equipments, the Bureau recommends that two of the fixed contacts on the rear switch be broken off to prevent the two loops from being together.

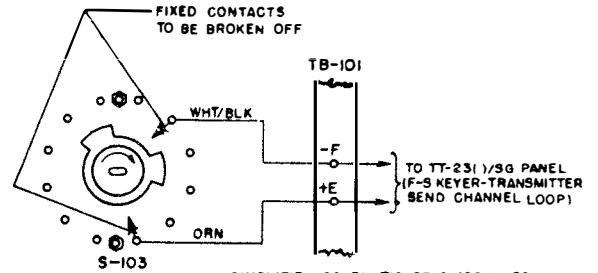
Figure 2

SIMPLIFIED SCHEMATIC OF C-1004A/SG SHOWING CONTACTS TO BE BROKEN OFF. IT IS TO BE NOTED THAT THE SWITCH IS DRAWN FROM A DIFFERENT ANGLE THAN THE REAR VIEW SHOWN IN THE PHYSICAL LAYOUT

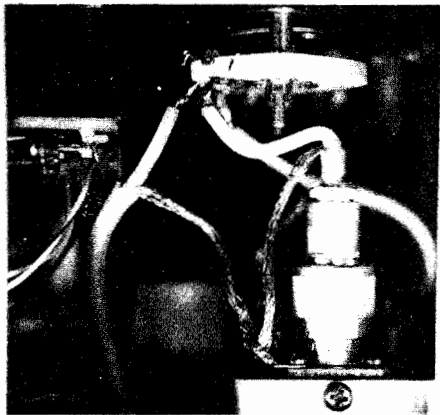
Figure 1. Installed cable RG-58()/U, Before Modification

A mismatch in present installations is caused by the extruded RG-58()/U cable, as shown in figures 1 and 2. To reduce this mismatch, the shield of the RG-58()/U cable should be terminated as close as possible to switch S1, with approximately one-half extrusion of center conductor and dielectric, as shown in figures 3 and 4. (701)
