AS-390/SRC, AT-150/SRC REPAIR METHODS FOR MATCHING SECTION

COMMUNICATIONS

NAVSEA 0967-LP-000-0010

SERVICE NOTES

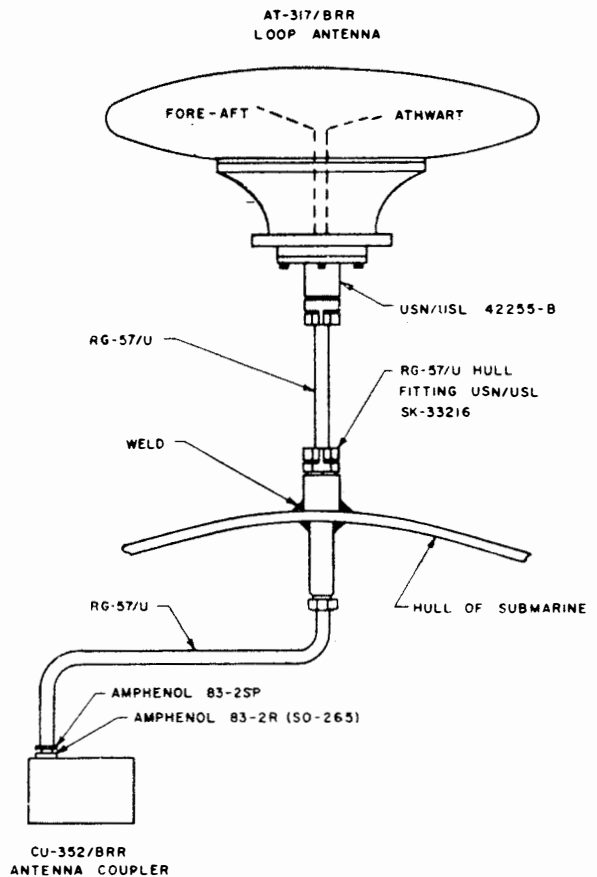
FIGURE 1

Recent inspections of AT-317/BRR Loop installations on submarines revealed the existence of the following deficiencies:

Recommendations to correct this default is contained in the following paragraphs. (See figure 1)

Plug, cable to coupler: Procure from stock or purchase: FSN N5935-666-1406 applies. This plug is identified in several ways: UG-1060 U, Navy type 49188, Signal Corps type PL-295, or Amphenol 83-2SP.

Receptacle: The CU-352/BRR coupler must be modified by replacing the large existing receptacle with the twinax receptacle identified as UG-1057/U, NT 49196, Signal Corps type SO-265, or Amphenol 83-2R. FSN N5935-149-2856 applies.

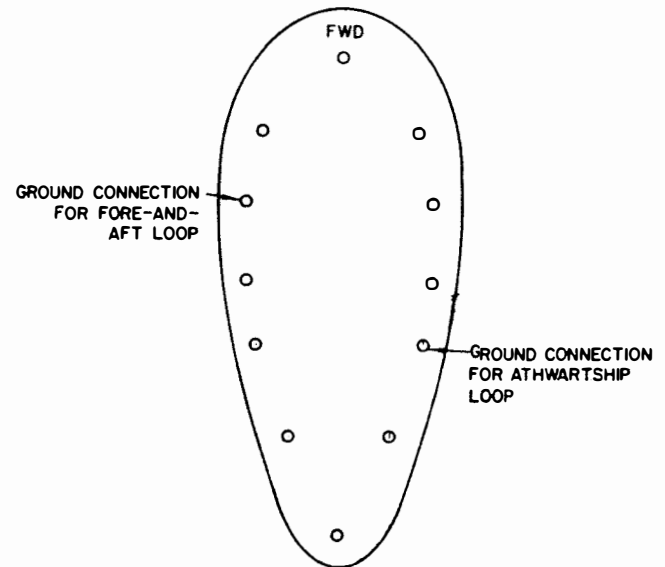
Figure 1. Bottom view of joint between antenna subassembly & mounting base of AT-317/BRR.

If sea water leaks into an AT-317/BRR antenna, the system sensitivity will be reduced. Since reception is still possible, and since each of the two loops has a very low resistance (about .1 ohm at the antenna or .3 to .5 ohm, including cable) and is grounded on one end, it is not possible to check for flooding in the usual ways. However, by removing two bolts at the antenna, the grounds are disconnected and a megger or ohm-meter can be used to check the insulation resistance from each loop to ground. (A megger may also be used for measuring loop-to-loop insulation resistance, but since the two windings are in contact, with only the varnish and a thin Teflon tape for insulation, do not use a megger which has a generator voltage of over 500 volts. It is better to use an ohm-meter for this measurement.)

After the two bolts are removed, the insulation resistance can be measured from the radio room. Assuming that the system is assembled properly, a low resistance reading (10,000 ohms or less) here means that the antenna is flooded. In this case the antenna must be removed from the ship. It is sometimes possible to restore the antenna to satisfactory operating condition by removing the mounting base, rinsing the antenna thoroughly to remove salt, and drying under a heat lamp (being careful not to overheat) for a period of a few days, until the insulation resistance is at least 50,000 ohms.

drying out the antenna and for tightening the bolts apply. In order to ensure and maintain watertightness, the bolts should be checked with the torque wrench when installed (especially on brand-new antennas), and at each upkeep period.

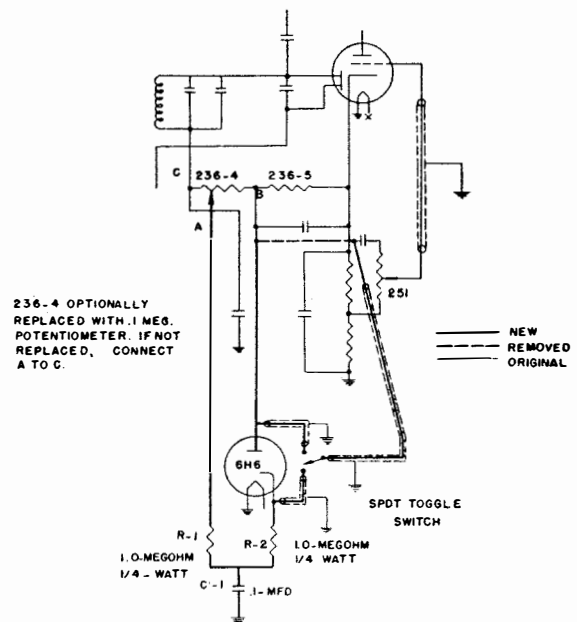
Figure 1.--Schematic diagram of noise limiter

The noise limiter to be described is suggested for the purpose of reducing interference to communications. The limiter will be especially effective on interference of a pulsy nature as it operates by cutting off the audio signal for the duration of any large noise peak.

Resistor 236-4 is shown as a variable potentiometer to permit control of the degree of noise limiting. It may be utilized without replacement with wire "A" connected to point "C".

Addition of this device to the receiver does not effect the i-f alignment provided the i-f circuit wiring is not tampered with. All parts except the 6H6, switch, R-1, R-2 and C-1 are in the original circuit. Placing the switch in the OFF position eliminates the limiter action. When used the limiter will cause considerable loss in signal strength and may, therefore, have to be turned off when used with a very weak signal.

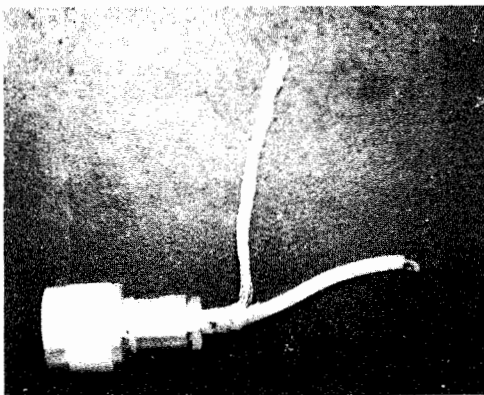
Figure 2. Present Method of Preparing Cable RG-58()/U.

A mismatch in present installations is caused by the extruded RG-58()/U cable, as shown in figures 1 and 2. To reduce this mismatch, the shield of the RG-58()/U cable should be terminated as close as possible to switch S1, with approximately one-half extrusion of center conductor and dielectric, as shown in figures 3 and 4. (701)

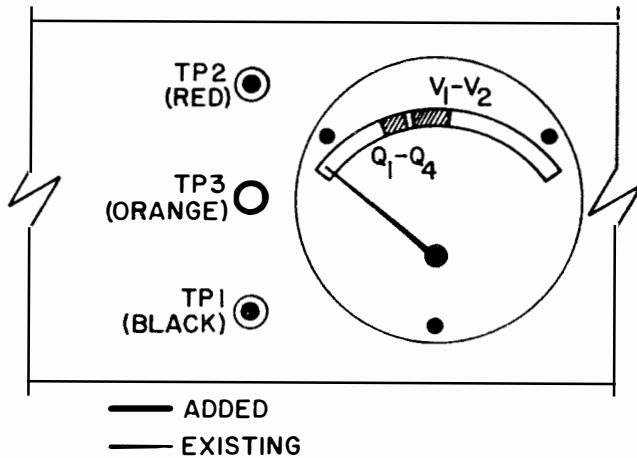
Figure 1. CU-1280/FRD-10A(V) Front Panel

Considerable time can be saved in calibrating CU-1280/FRD-10A(V) test meters if a third test point is added to allow calibration from the front panel.

1. Install a third test point (TP3—color: orange) mid way between TP1 (black) and TP2 (red) on the CU-1280/FRD-10A(V) front panel. See figure 1.

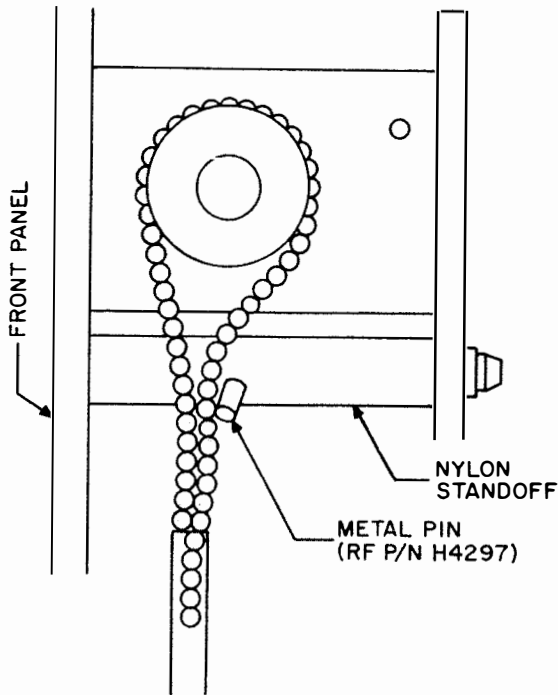
Figure 1. Top View of Coupler, Showing Location of Metal Pin.

The following method of preventing the bead chains from coming off the brass sprockets on the fine tune and load counters has been incorporated into all new Manual Antenna Coupler CU-1457/URC-58(V) production models. The change can be installed easily in units already in the field. This change can be installed without any disassembly of the unit, except for removal of the top cover.

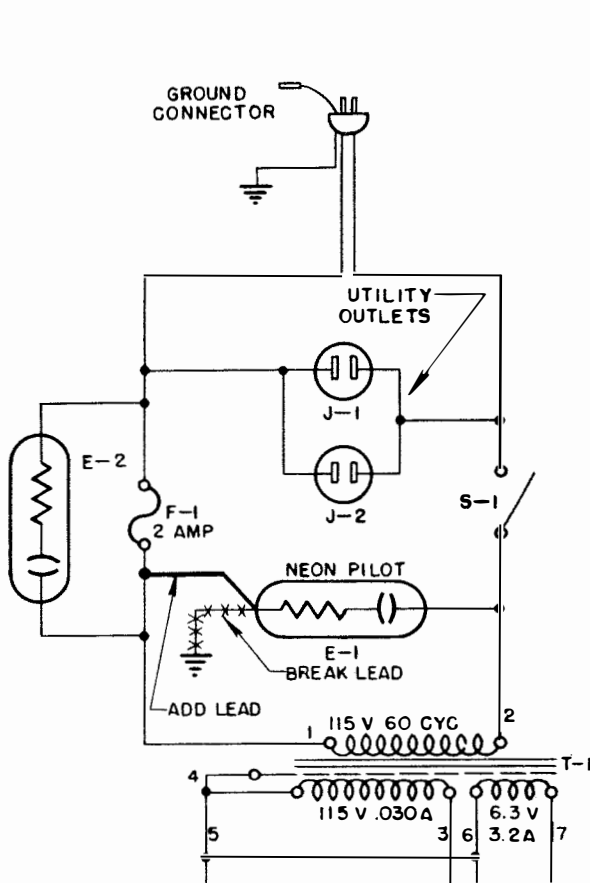
**CORRECTIONS TO SCHEMATIC DIAGRAM
FIG. 6 OF NAVSHIPS 91394**

Field activities have reported that the on-off indication of the neon pilot lamp (E1) of Frequency Shift Converter CV-172/U is not definite when the converter is operated from an ungrounded primary power input line. For this type installation, the Bureau authorizes a rewiring of lamp E1 in accordance with accompany-illustrations.

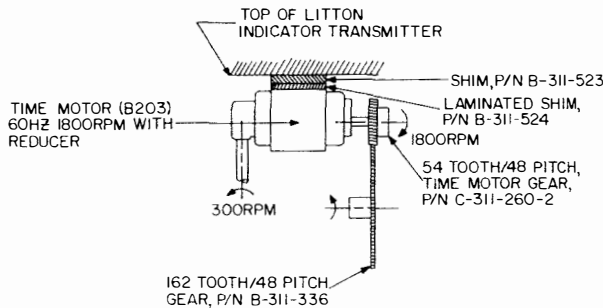
Several equipment holders have indicated that a problem has been encountered in the Time Motor (B203) output gear train of the Litton Industries Indicator Transmitter. For the following discussion, refer to the Litton Industries Indicator Transmitter Technical Manual, NAVSEA 0365-LP-292-0000 (dated 23 September 1975), pages 7-56 through 7-58. Specifically, the 1800 RPM output gear (54 tooth/48 pitch), part number C-311-260-2, piece number 37 has experienced faster than normal gear wear in some installations. This gear is made from Teflon and meshes with a 162 tooth/48 pitch, Naval Brass gear.

After close evaluation it was determined that proper shimming of the Time Motor (B203) is critical and essential to ensure proper tooth engagement between the 54 tooth Time Motor gear and its mating 162 tooth gear. During the initial factory assembly of the Indicator Transmitter, the shims were installed, but through years of repair, parts replacement and overhaul of the units, it was discovered that quite often these shims were either lost or not reinstalled. Incorrect shimming will result in accelerated wear of the softer Teflon gear. Referring to page 7-34 of the technical manual, both Time Motor shims are shown (piece number 22, part number B-311-523 and piece number 23, part number B-311-524). Although the technical manual specifies shims, there are no drawings describing their physical construction, or gear alignment procedures. Additionally, the shims cannot be ordered through the supply system for they are unexpendable hardware items and are not listed on the Allowance Parts Lists (APLs 870090006 or 870090015. Thus, if the shims were lost, there wasn't any technical information concerning proper replacement.

This maintenance hint provides three drawings to aid in the correct alignment of subject gear. Figure 1 provides information for correct alignment for Time Motor Gear. Figures 2 and 3 depict the manufacture of both shims.

1. Install shim (P/N B-311-523) and laminated shim (P/N B-311-524) on time motor (B203) and bolt to top of indicator transmitter.
2. Check for proper tooth engagement between time motor gear (54 tooth/48 pitch), P/N C-311-260-2 and the (162 tooth/48 pitch) gear, P/N B-311-336.
3. The fit should be snug, yet free enough to allow the gear train to rotate.
4. Unbolt time motor (B203) and both shims (B-311-523 and B-311-524) and remove sufficient number of laminations from laminated shim, P/N B-311-524 to provide proper fit.
5. Repeat steps 1 through 4 until proper gear mesh is obtained.

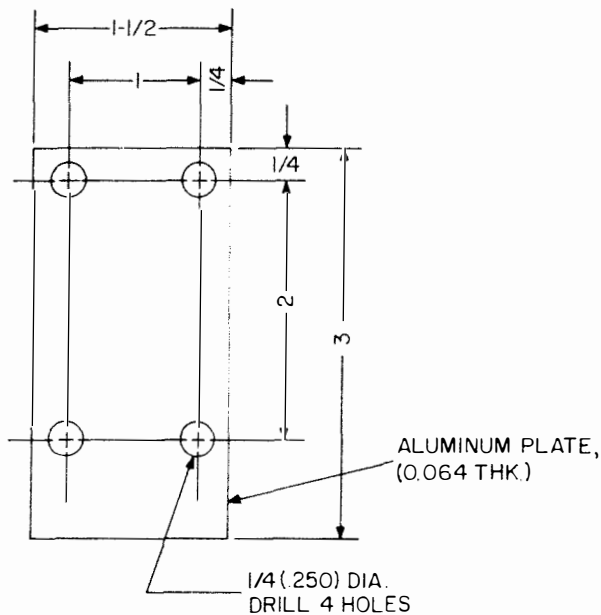
Figure 4. Litton Indicator Transmitter Shim for Differential Unit Assembly. (From Dwg. SK4270035, Rev. A.)

Correspondingly, the same philosophy exists for the shimming of the Differential Unit Assembly. Figures 4 and 5 depict the manufacture of both shims for the Differential Unit Assembly. The basic concept of the alignment procedure for the Time Motor can be applied to the Differential Unit Assembly. Any questions concerning this article, can be directed to NAVSECNORDIV, Tom K. Kamalsky, Jr. Autovon 690-9325.

1. Remove all burrs and sharp edges.
2. Shim (Litton Part Number B-311-522) is utilized to provide alignment of the time motor (B203) gear (22 tooth/48 pitch) with its mating gear (66 tooth/48 pitch) of the differential unit assembly.
3. This shim works in conjunction with laminated shim (Litton Part Number B-311-525).
4. This shim must be manufactured, not available in supply system.

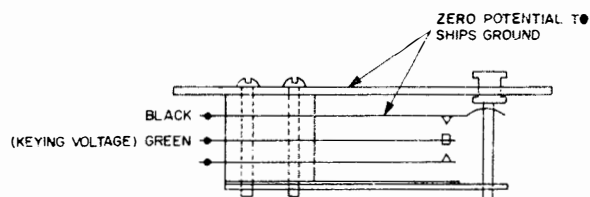
Figure 1. Push-to-talk switch handsets H-169/U and NT-51007A.

It has been reported that a shock hazard exists on a few Navy handset types H-169/U and N. T. 51007A. This is caused by a misalignment of the leaf of spring of the switch which shorts the push-to-talk button (metal) shaft and, in turn, places the keying potential on the plate of the switch. When the switch button is engaged or released, an inductive kick-back potential is present on the switch plate. If a handset is considered to be a shock hazard, or if a continuity check indicates a short between the switch plate and the plug pins, the handset should be modified as follows:

1. Re-align the pile-up of the push-to-talk switch in order to prevent shorting to the metal shaft.
2. Reverse the green and black leads of the switch, which removes the keying voltage from the leaf spring which, in turn, shorts to the metal shaft. Figure 1 shows the modified wiring diagram of the handset switch.
3. Determine whether excess solder is causing the short.

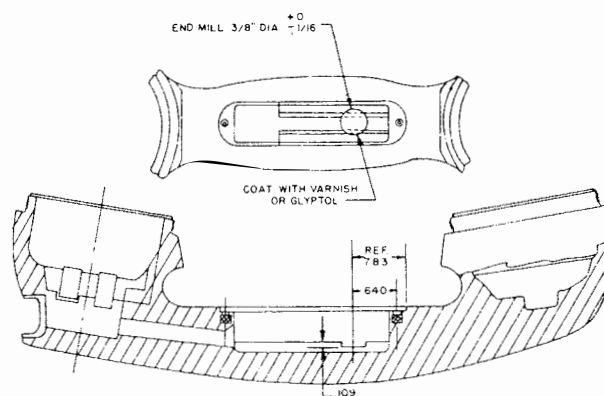
Figure 1. Handsets H-169/U and NT-51007A, Modification Dimensions

It should be noted that the difficulty is not apparent upon visual inspection, but develops while the handsets are in actual use. If, upon depressing the button at a slight angle, the switch short circuits to the two brass rails, the handset should be modified by machining the rails as indicated in figure 1.

Specifications have been modified to prevent future procurement of handsets with the defects indicated above. (631)

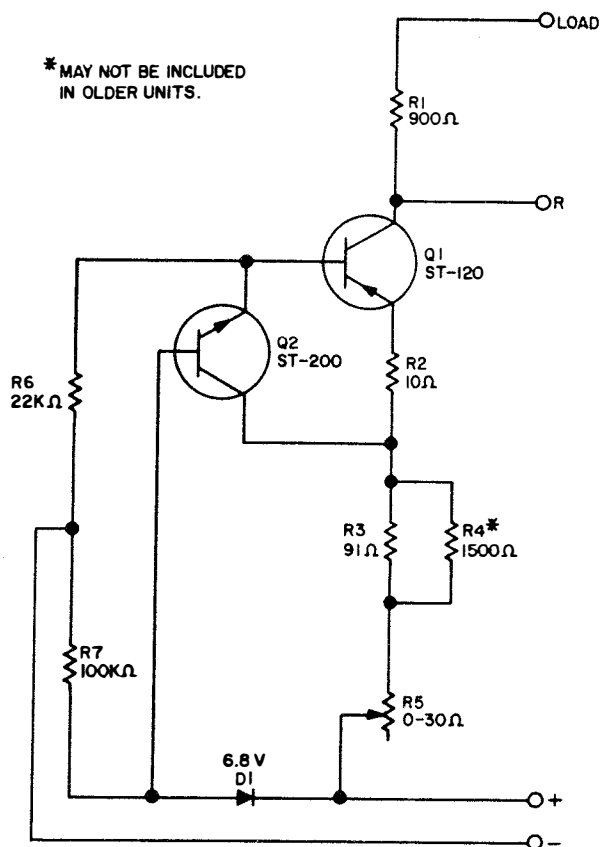
Figure 1. STELMA Model LC-3 Constant Current Rheostat

Failure Symptoms:

1. No regulation
2. Low current
3. No adjustment possible

Common Cause of Failure:

1. R-3 Changing value
2. R-5 broken
3. Failure of one or both transistors

1. Remove four press fit rivets and lift cover from unit.
2. Test components for failure or change in value.
3. Remove defective component and replace with new one from stock. Resistors are all $\pm 5\%$ tolerance. Equivalent substitute transistors may be used if the recommended ones are not available. Upon completion of repairs, the unit shall be tested for proper operation before being re-installed.

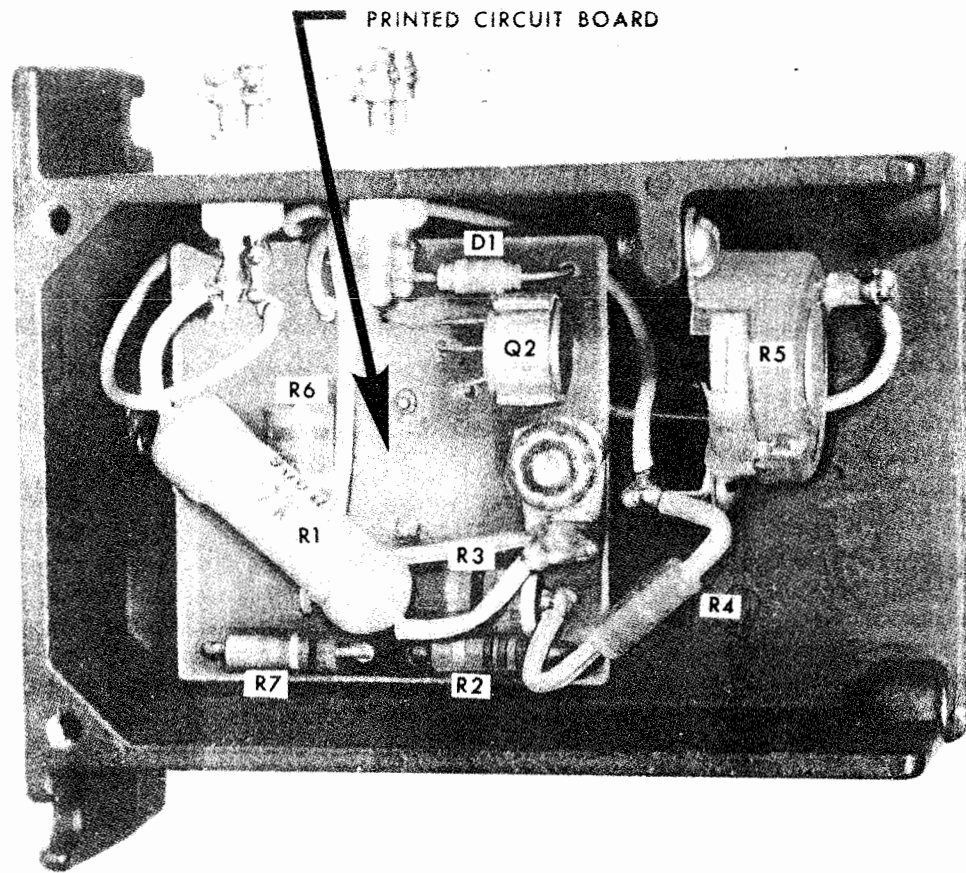
Figure 2. Component Layout (Printed Circuit Board)

Two mechanical configurations of the LC-3 rheostat are being used. The circuit, figure 1, is the same for both configurations. Figure 2 and figure 3 show the general component layout of the units. Table 1 is a description of all components in the LC-3. These components are generally available through supply channels.

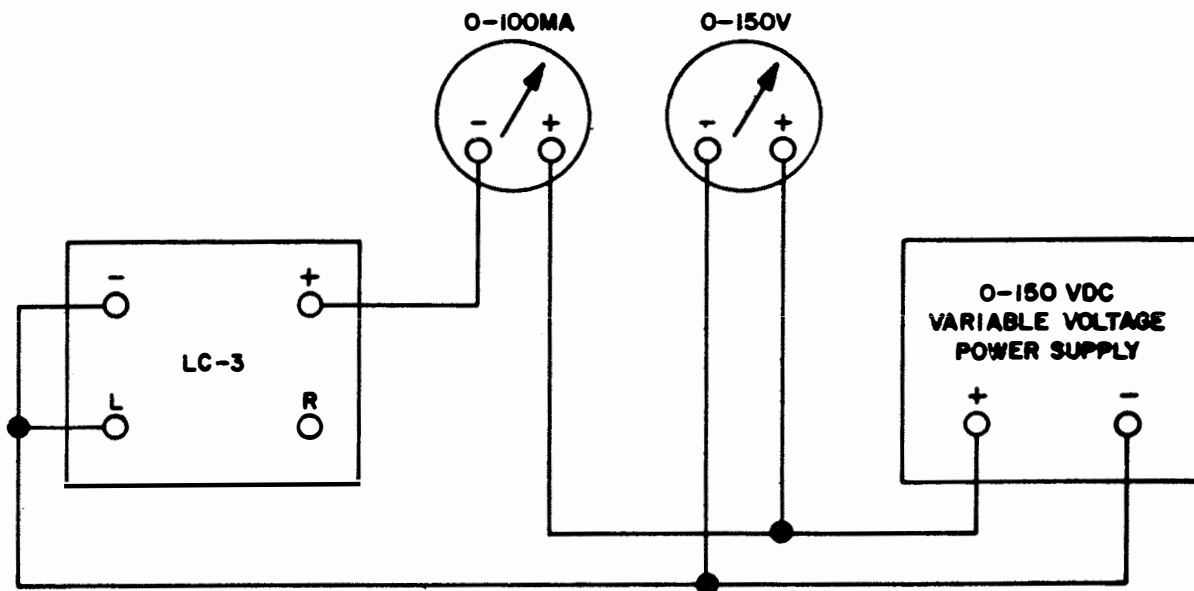
Figure 4. Test Set Up

1. Connect terminals L and - to the negative side of the DC supply as shown in figure 4.
2. Set up one meter to measure 0-100 MA and place it in series with a line from the LC-3 + terminal to the DC supply + terminal.
3. Connect the other meter to measure the power supply DC voltage.
4. Turn the supply on and adjust the output to 100 volts.
5. Adjust the LC-3 potentiometer for 60 MA current.
6. While observing the MA meter, vary the voltage of the power supply between 65 and 135 volts. A properly functioning LC-3 should maintain 60 MA \pm 2 MA over the entire 65 to 135 volts range.

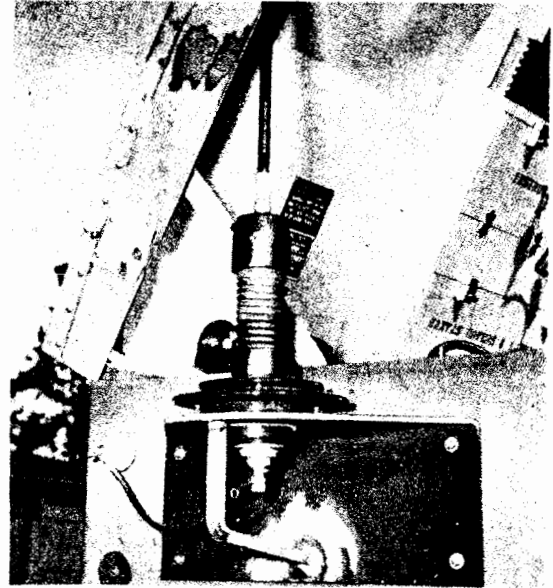
Figure 1.--Method of mounting a type MP-37 whip assembly on an MAM equipment

The necessity for communication with aircraft 5 and 10 miles distant from the signal officer requires more radiation than is obtainable from the whip antennas furnished with MAM equipments.

The photograph of Figure 1 shows a close-up of the method employed in mounting a complete type MP-37 whip assembly, including the spring base employed to prevent the whip from snapping off.

The above antenna modification may be made if it is necessary to maintain communication over distances greater than was originally intended.

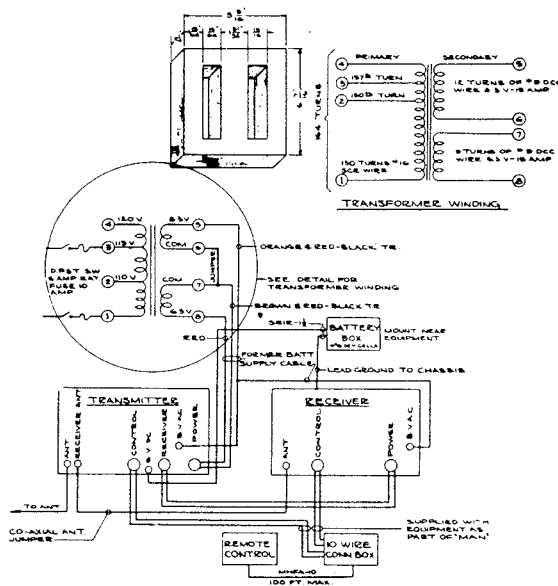
Figure 1.--Details of the transformer and interconnections needed for the modification

A 10-wire connection box must be mounted within 3 feet of the transmitter and receiver (see fig. 1). This connection box is to splice the leads coming from the MAN equipment and the remote head if one is used. When wiring the remote, note that the numbers attached to the wires from the equipment correspond to numbers on the terminal board in the remote control head. Do not connect wire No. 1 to pin No. 1 on the plug, that is, pins on plugs do not correspond to numbers taped on wires.
